Corrosion protection under insulation

To ensure controllable processes with little energy loss, columns, equipment, and pipes in refineries are insulated. Breaches in the insulation permit corrosive media to destroy the base material under the insulation. When an abandoned oil field in the Netherlands was reopened, the whole piping system was coated using *Anti-corrosion Solutions* from Sulzer Metco that guarantees protection for over 25 years and thereby reduces life cycle costs.

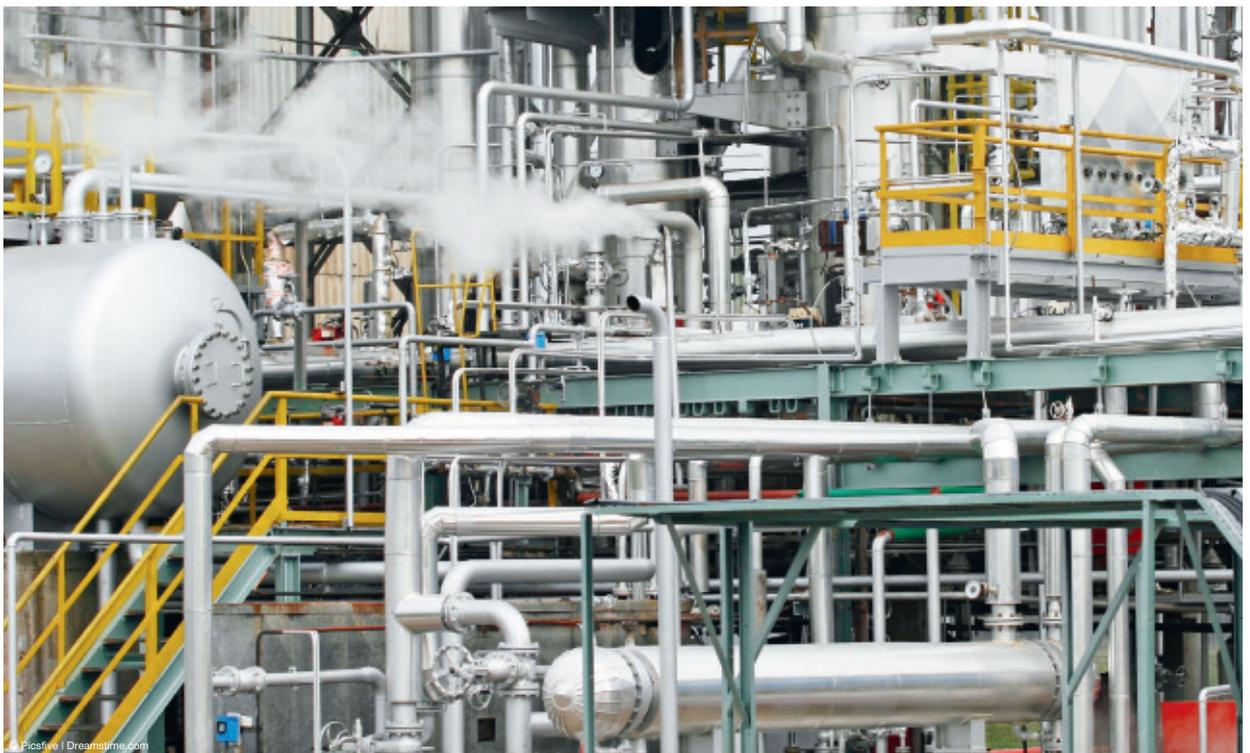
[1] Section of a refinery—the piping can be exposed to aggressive fluids under the insulation.

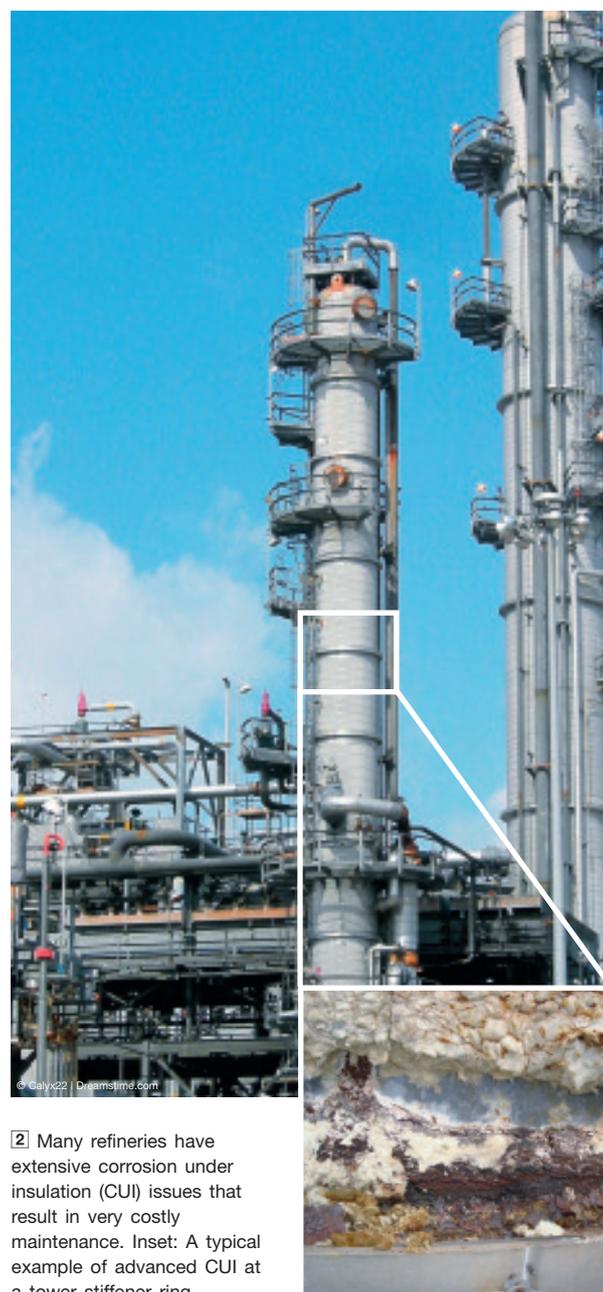
[2] Many refineries have extensive corrosion under insulation (CUI) issues that result in very costly maintenance. Inset: A typical example of advanced CUI at a tower stiffener ring.

environmental damage create entry points for corrosive media. This corrosive media is most often water contaminated with chlorides and sulfates, which gives rise to corrosion under insulation (CUI) [2].

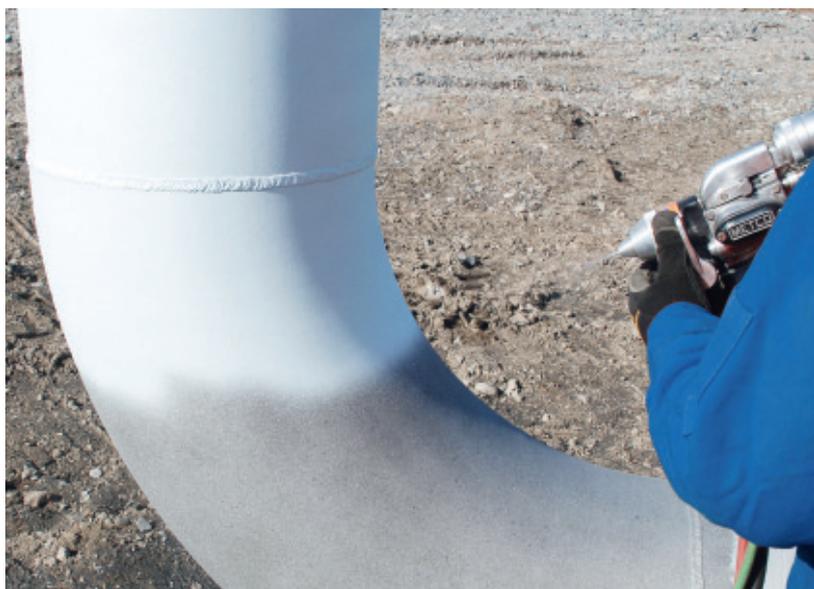
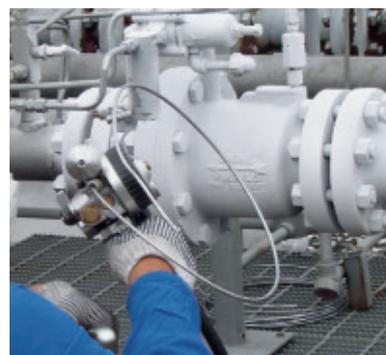
[5] A typical pipe coating system as used with the *Anti-corrosion Solutions* of Sulzer Metco. On-site application of TSA.

The whole piping system with a length of 25 km was treated with the *Anti-corrosion Solutions* from Sulzer Metco [5].
