Improvement of compressor rotors

Lifetime extension with hardfacing

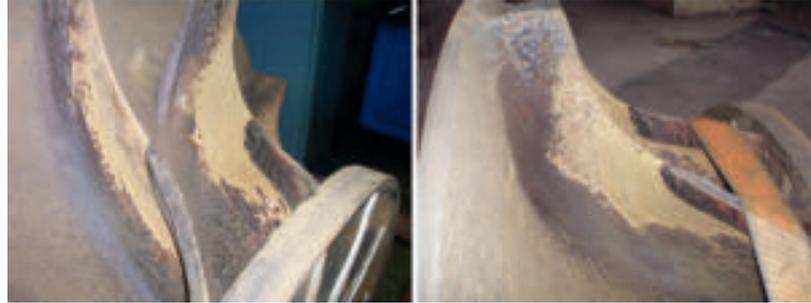
2 Laser cladding is particularly suitable for applications that demand high dimensional accuracy. Because of the superior focusing ability of laser, components can be processed with minimal thermal loading and distortion. Sulzer has long-standing experience in laser cladding and has performed a great variety of laser applications for customers all around the world.

Sulzer decided to apply the layer by laser cladding in order to overcome the disadvantages of manual arc welding.

To keep the Stellite layer within controlled parameters (thickness and location), Sulzer engineers decided to apply the layer by laser cladding (Fig. 2) on the individual vanes before they were assembled and final welding was performed. In a cooperative effort with the welding department of Sulzer Innotec, Sulzer Turbo Services performed tests to assess the quality and continuity of the welding layer. After several test welds on a base material comparable to that of the impeller vane, samples were made to

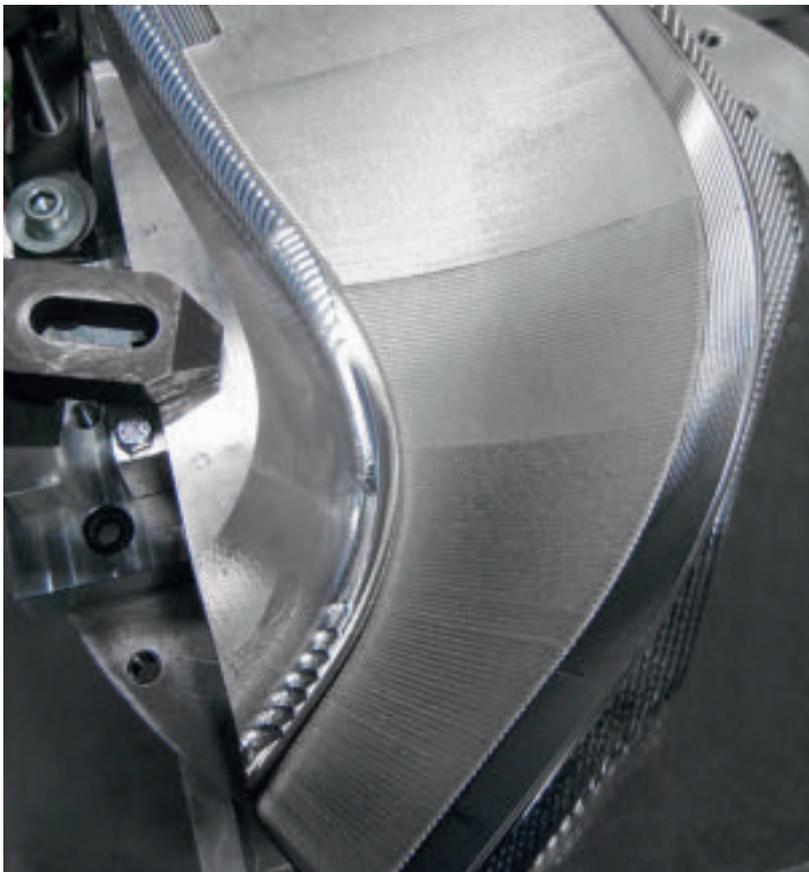
4 To keep the relative position of the blade in the base material measurable during the production process, Sulzer engineers machined reference planes and notches into the base block.

The vane's geometry was machined using 5-axis computer numerical control (CNC) out of a solid piece of forging. The machining was executed in several individual steps with intermediate dimensional inspections. This approach made it possible to measure and correct any deviations from the desired geometry after laser cladding and heat treatment. To generate the model for the 5-axis machining, Sulzer engineers extracted the blade geometry from the available 3D model of the rotor/impeller and positioned it in the most convenient setup for machining and laser cladding (Fig. 4).
